Revitalization and landscape design of the park in Stari Mikanovci, Croatia; role of existing vegetation in generating new landscape solutions

Monika Kamenečki^{1*}, Aneta Mudronja Pletenac¹, Helena Miholić¹,
Dora Tomić Reljić¹, Daniel Krstonošić², Petra Pereković¹

¹University of Zagreb Faculty of Agriculture, Division of Horticulture and Landscape Architecture,
Department of Ornamental Plants, Landscape Architecture and Garden Art, Croatia

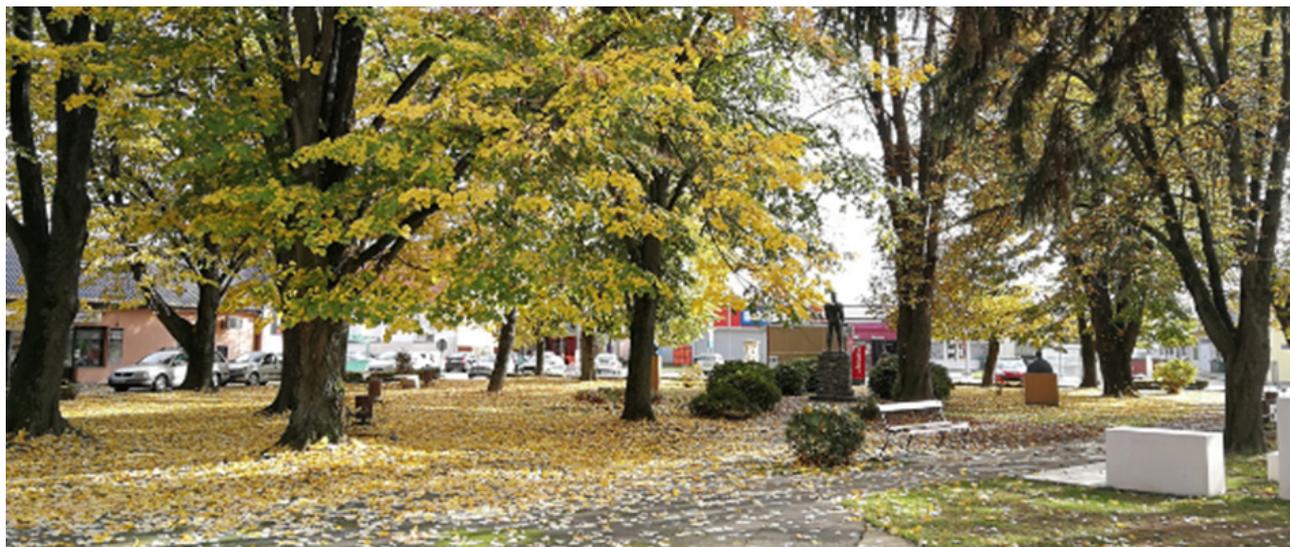
Figure 1 Park Stari Mikanovci, Croatia (2019)

1.2 Characteristics and condition of the park Stari Mikanovci, Croatia

The park is located in the central part of the settlement, and it is an important point of gravity with its historical centre (Nesek Ltd., 2005) along with an archaeological site close by (Ministry of Culture and Media). The research area was chosen because it is the only public park in the settlement around which all municipal institutions and a church are positioned and it also represents the centre of all social events of the community. The central open area of the settlement does not have the characteristics of a recognizable and representative open urban space. Existing space content does not provide diverse and meaningful use for the local community and it does not promote environmental value. The park has the characteristics of a transit space that allows movement and easy access to public facilities, but not additional features that allow or encourage hold and stay. The total area of the park is 2,920 m², of which 1,539 m² are green areas and 1,318 m² are paved areas (Fig. 1). The park is bordered on three sides by roads, so there is a direct visual and physical connection which prevents quality use of space. The northern edge of the park is defined by the municipal building, which requires a dense network of communications in the northern part of the park. Currently, the park has only elementary uses – movement and use of benches. The composition of the park seems random and unrelated, which is due to the diverse materials, shapes and colours of the structural elements of the park upgraded through the decades of use. The basic spatial features of the park include a large proportion of tall trees with broad canopies that exceed almost the entire area of the park. The temporal trees of the park also make a kind of memory of the place. For these reasons, a detailed analysis of existing vegetation is envisaged as a prerequisite for future spatial intervention. The result of such an analysis is the vitality of the tree, conservation guidelines, determination of maintenance measures and guidelines, and the production of unambiguous data on

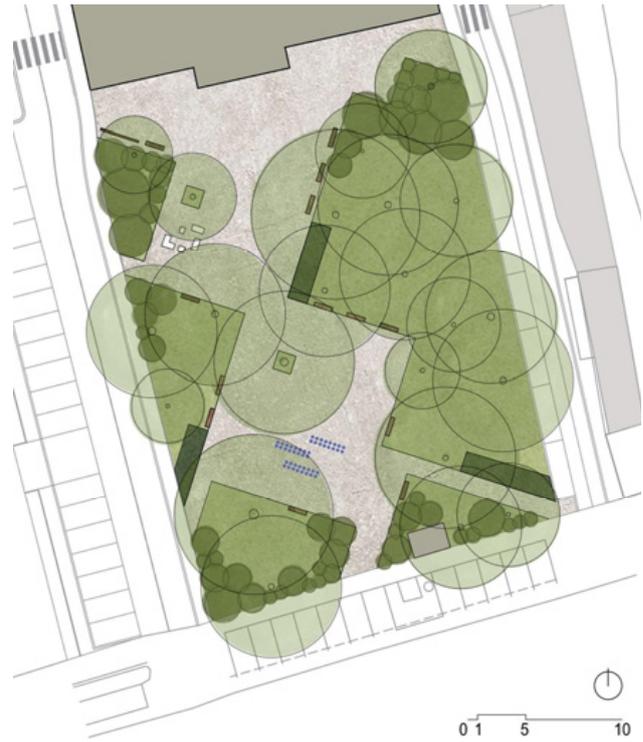
Figure 7 Concept 2 – design basis

Concept 2 “Superposition of grids” (Fig. 7). The proposed design generates its geometry from the need to organize and by evading the given existing geometry of the surrounding urban elements. The squares are formed by overlapping two regular square surfaces. The northern square is proposed for festivities and events, and the southern square provides a living area for everyday stay in the park. The entrance is placed in the same direction of the new geometry. The connection to the south-western

and south-eastern border of the park and immediate surroundings is established by the seemingly irregular geometry of higher and lower vegetation, and elongated rectangular surfaces of ground cover and shallow volumes of evergreen and aromatic plants.

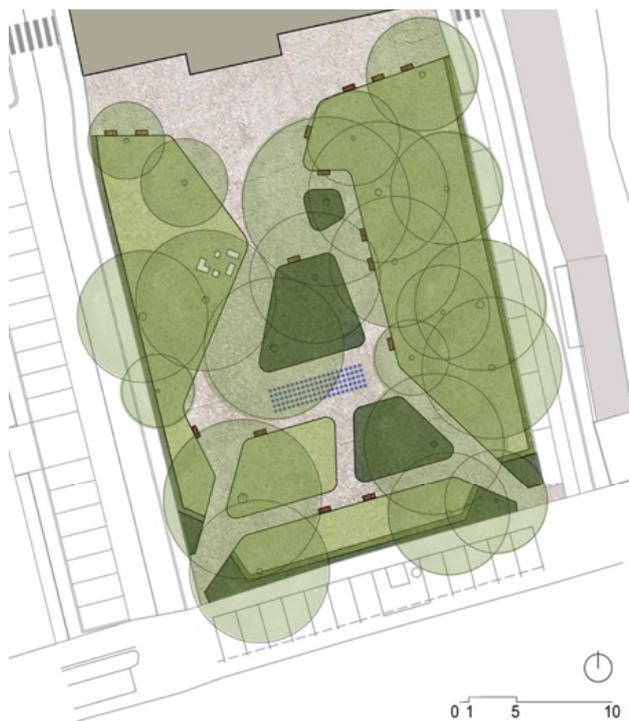
Figure 8 Concept 3 – design basis

Concept 3 “Symbolic expression” (Fig. 8). The design is derived from an archaeological find – a double vessel (jug) of the Vučedol culture, which is the basis of the artistic form of expression of the park itself. The memory of the existing communications has been preserved, and the central square-like space of the park has been created, which is further divided into irregular trapezoidal surfaces with planted perennials, ground cover and shrubs. Two larger residential zones and two sub-zones intended for events and residential activities have been established. The relationship to the park edge is completely uniform, a structure overgrown with climbers

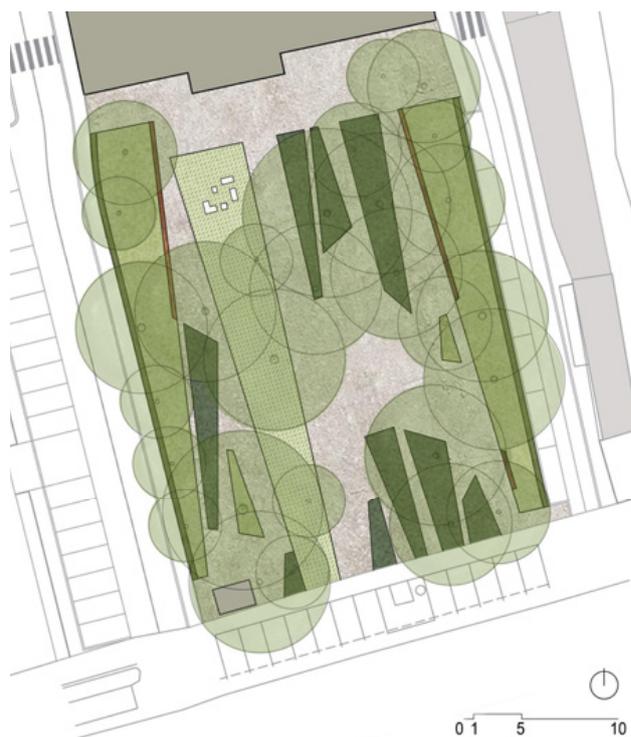
Figure 9 Concept 4 – design basis

Concept 4 “Abstraction of landscape elements” (Fig. 9). The design is a modern reinterpretation of the urban

landscape in which a clear distinction is lost between the boundaries of individual functional elements: path, lawn, square, park. This design transfers the landscape pattern of the plain field by abstracting the wider environmental context into the park experience. The elongated surfaces with perennial plantations divide the space into fields and images of experience.
