Acta Horticulturae et Regioteecturae 1
Nitra, Slovaca Universitas Agriculturae Nitriae, 2019, pp. 41–47

OBJECTS OF SMALL SACRAL ARCHITECTURE AND LANDSCAPE – CASE STUDY OF THE COMMUNE OF ŽIRANY

This study aims to analyse existence, technical condition, origin and history of objects of small sacral architecture in the area of the Tribeč Mountains, specifically as a case study in the commune of Žirany. It defines different types of objects, mostly small chapels and crosses and specific phenomenon of small boxes with sculpture of saints installed on the front facades of residential houses. The study also focuses on the relation between small sacral architecture and existence of elements of greenery. As a result, the work presents a detailed description of the individual mapped elements and an overview map showing the objects in the cadastral area of Žirany.

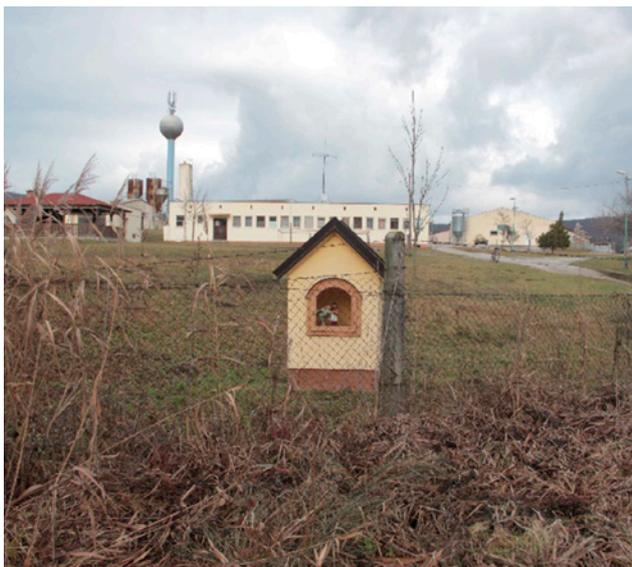
Figure 1 Chapel of St. John of Nepomuk
Photo: Fusková, 2018

between rural and residential zone of the village on the premises of the Agricultural farm of the Slovak University of Agriculture (Fig. 1). Chapel's interior contains a small sculpture of St. John, small vase with flowers, cross and candles (Fig. 2). This object is built of brick, it is newly reconstructed and in perfect condition (value 0 for technical condition), with new painting, roofing and window. It is one of smaller chapels found in the area; it has 1.2 × 1.2 m size in base and 1.6 m in height. The object is simple, painted in light yellow colour without any writing or decorative ornaments; its surrounding is also simple, without fence. In respect to greenery, this object stays without any, there are few trees newly planted, but they are part of the farm greenery without any historical context. Evidence in historical maps can be seen in the Map of Third Military Survey (Fig. 14) and the Military Survey of Hungary (Fig. 16).

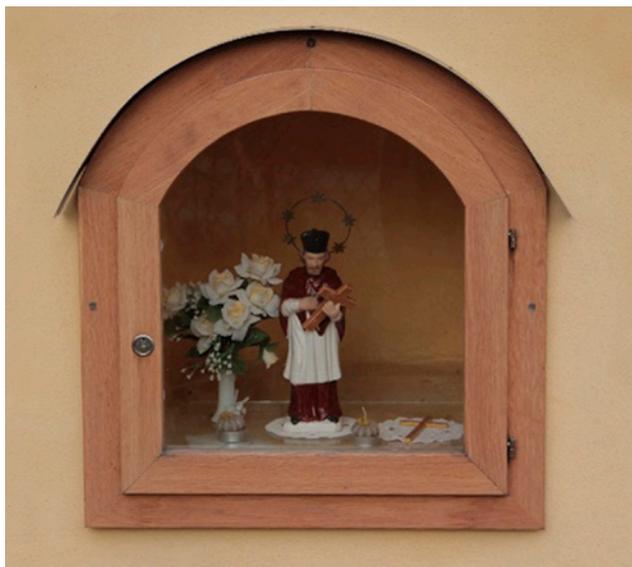
Figure 2 Chapel's interior
Photo: Fusková, 2018

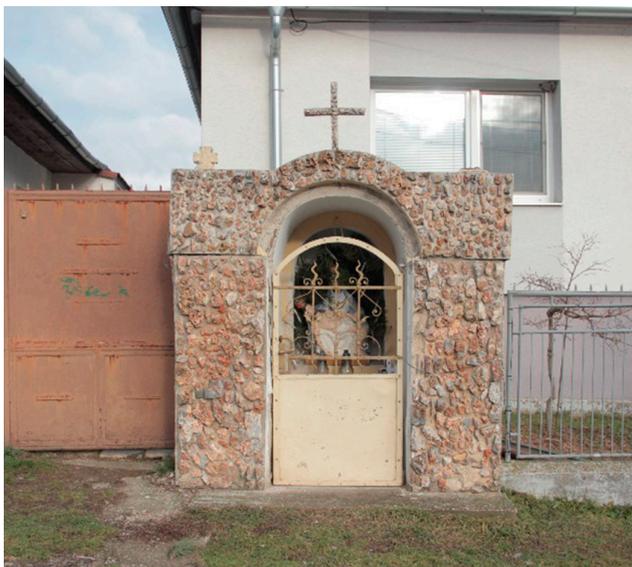
Chapel with Pieta is situated in front of the residential house number 82 on the main road in the old residential area (Fig. 3). The object is built of brick, the front side of the chapel is lined with limestone, behind the pale-yellow metal doors there is a sculpture of a gracious appearance – Mother with dying Jesus (Fig. 4). The chapel is in good condition, it has no damage (value 0 for technical condition), the internal sculpture decoration is highlighted at night. In respect to sizing, the object has 1.6 × 1.2 m in base and 2 m in height. There are no writings or ornaments, the chapel forms a part of the fence. There is no evidence of greenery and historical maps do not register the object. The estimated origin of this monument is the second half of the 20th century.

Figure 3 Chapel with Pieta
Photo: Fusková, 2018

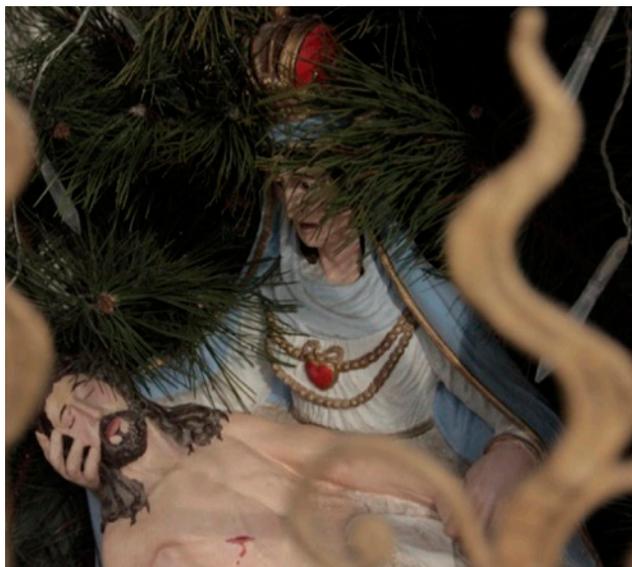
Figure 4 Detail of chapel's interior
Photo: Fusková, 2018

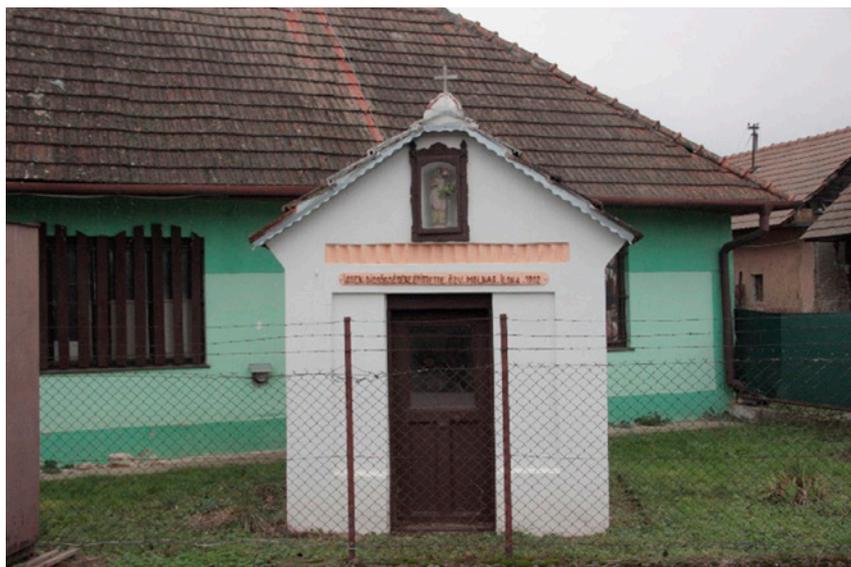
Figure 5 Chapel of St. Vendelin
Photo: Fusková, 2018

faces the street, and both sides of the chapel are planted with *Yucca*, sp. (Fig. 5). The chapel is built of brick, painted in white colour, with roofing and dark brown wooden door. It has 1.5 × 1.5 m in base size and 2.2 m in height. There is one-line writing on the light orange line: 'Isten. Dicsőségére. Építette. Özv. Molnar. Ilona. 1912' (God. Glory. Built. Widow. Molnar. Ilona. 1912). Above writing there is an ornament painted in the same colour and more above a small wooden box with the statue of Virgin Mary (Fig. 6). Behind the door there is a sculpture of St. Wendelin dressed as a shepherd along with sheep. The object is well maintained,

without any sign of damage (value 0 for technical condition). Only greenery presented is the yucca plantation mentioned above. According to the data mentioned on facade, there cannot be any evidence in historical maps from 18th and 19th century, it was not also marked during the Hungarian Military Survey in 1941.

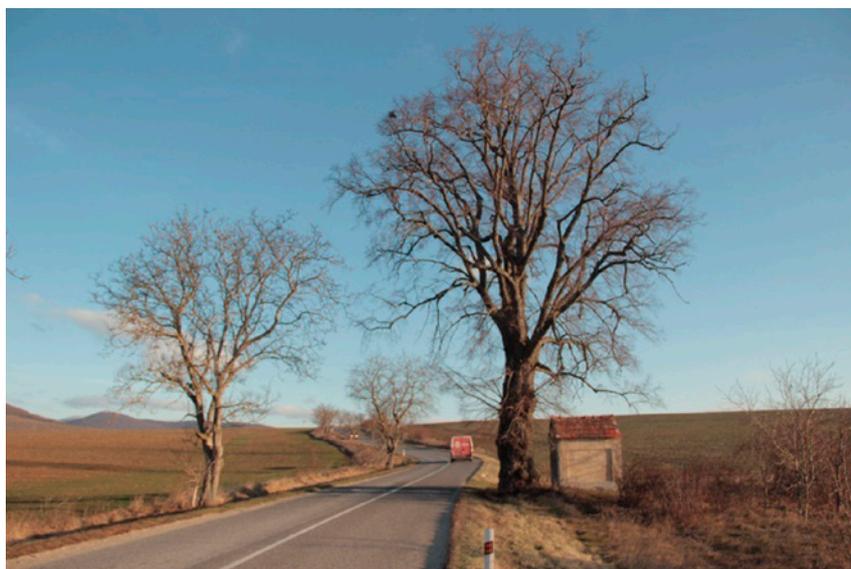
Chapel of St. Andrew the Apostle built in 1895 by Michal Dubnický (Municipality of Žirany, 2010) is situated in the rural zone in the Žirany cadastral area on the crossroad Jelenec – Koliňany (Fig. 9). The object is oriented towards the landscape with a view line on the Tribeč mountain

range. It is built of bricks, with cement plaster, roofing and green metal doors. It has 1.5 × 1.5 m in base size and 2 m in height. Its technical condition is not perfect, but it does not show significant signs of damage, except of graffiti on one side of the object, rather it may be a partial neglect resulting from the locality and high traffic pollution (value 2 for technical condition). In respect to greenery, this object is interesting as it is the only one adjacent to the growing tree. *Tilia cordata*, Mill. which grows at the right side of chapel has 272 cm in trunk circumference, 12.5 m of crown spread, 20 m in height, it represents value 5 (veteran) for its age by Šimek (2001), value 4 for its landscape-architectural value by Machovec (1987). According to Juhásová (2009) it represents 2nd degree of health condition and degree of damage. The record of the chapel in

Figure 7 Chapel of St. Andrew the Apostle with tree *Tilia cordata*
Photo: Fusková, 2018

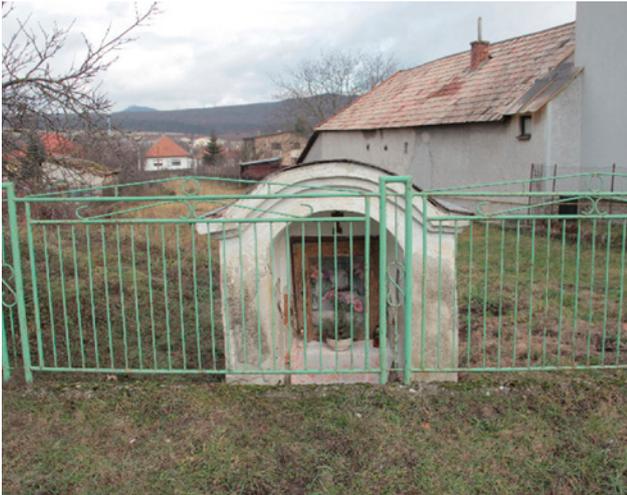
Figure 9 Chapel nearby main road
Photo: Fusková, 2018

Chapel situated near the main road (Fig. 9) has not any evidence in municipality chronicle. Deducing from the outlook, which the sculpture depicts inside the chapel, this one is also dedicated to the Mother with dying Jesus – Pieta (Fig. 10). It is a part of the private land property, facing towards the main road from which it is separated by a low green fence. This small chapel (1 × 1 m in base, 1.2 m in height) is built from bricks with vaulted roof and has no writing or ornaments at plaster. The technical condition is poor, the white plaster is much damaged, the bricks are visible in many places (value 3 for technical condition, damage tends to be 50%). There are no trees tied to the object, a pair of fruit trees on the left side belongs to the neighbouring land. Evidence in historical maps shows that the chapel was marked during the Second Military Survey of the Habsburg Empire (Fig. 14) as well as later at the map of the Third Military Survey of Habsburg Empire (Fig. 15) and Military Survey of Hungary (Fig. 16), so it could have been constructed by the end of the 18th or the beginning of the 19th century.

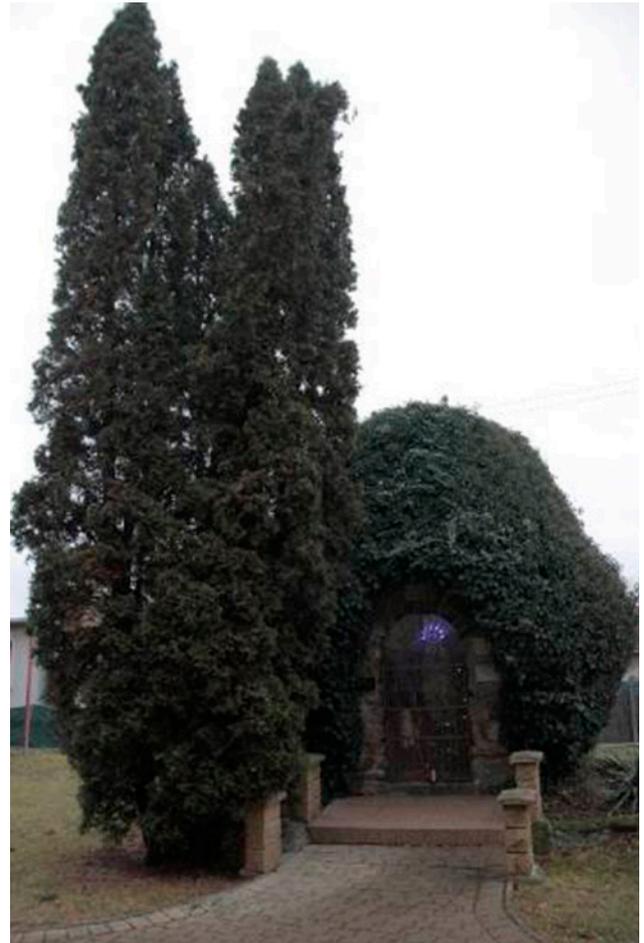
Figure 12 Lourdes cave
Photo: Fusková, 2018

Another sacral object – a Lourdes cave is located next to the church, it was built in 1927 by Valent Gál and his wife Carolina (Municipality of Žirany, 2010). Technically, it is in good condition, its interior contains sculpture of Virgin Mary of Lourdes. The object is built of stone, which also forms its exterior tiling, the base has dimensions of 2 m and height about 4 m (most of the building is massively covered by the plant *Hedera helix*, L.). There are three tables with writing in Hungarian, one speaks of the founder and the date, and others are the tables of gratitude of the Virgin Mary. The value for technical condition is 0, in surroundings, *Thuja occidentalis*, L. is present. The trunk circumference is about 50 cm measured 20 cm above the ground, its age is valued as 5

(veteran), crown width is 1.6 m, height of the tree is 8 m. Landscape-architectural value is 3 and health condition and degree of damage is 3, as a notice – the crown is wide and in upper parts starts to divide in more segments. The object was not marked during the Military Survey of Hungary in 1941.

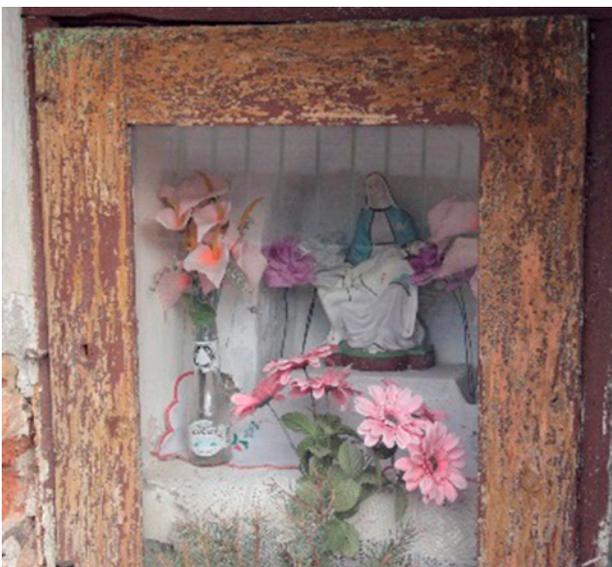
Figure 10 Detail of sculpture
Photo: Fusková, 2018

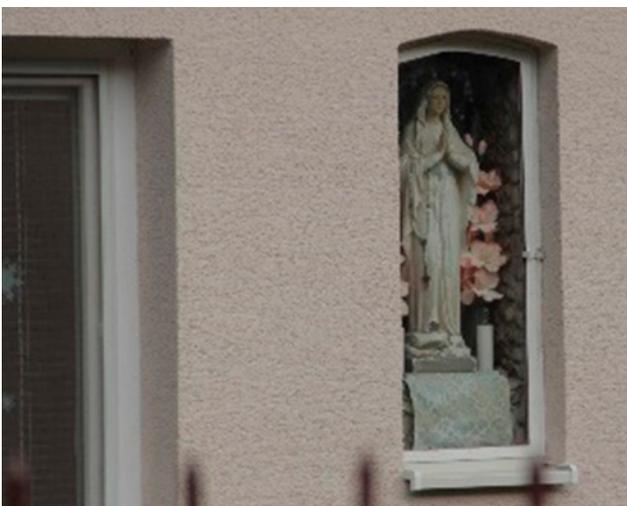
Figure 11 Example of small boxes with sculptures
Photo: Fusková, 2018

SSA in form of small boxes with sculptures of saints as a part of front facade of residential houses is one of the local specificities (Fig. 12); these objects were not found in neighbouring villages in such abundance and so many different shapes. In the Jelenec commune, there were 2 small facade boxes, in Hrnčiarovce only one object, in Beladice two small objects. There were mapped 18 objects of sacral facade boxes of different shapes and materials, predominately with sculptures of Virgin Mary or Jesus. The boxes were situated in central parts of facades between windows of the houses build in 1960's. The size of the window with the statue is almost the same as the windows on both sides of the box. One of the boxes (Fig. 13) was found in a residential garden in the form of a metal box 0.4 × 0.4 m sized in base and 0.5 m in height, standing on two thin metal pillars 1.3 m above ground.

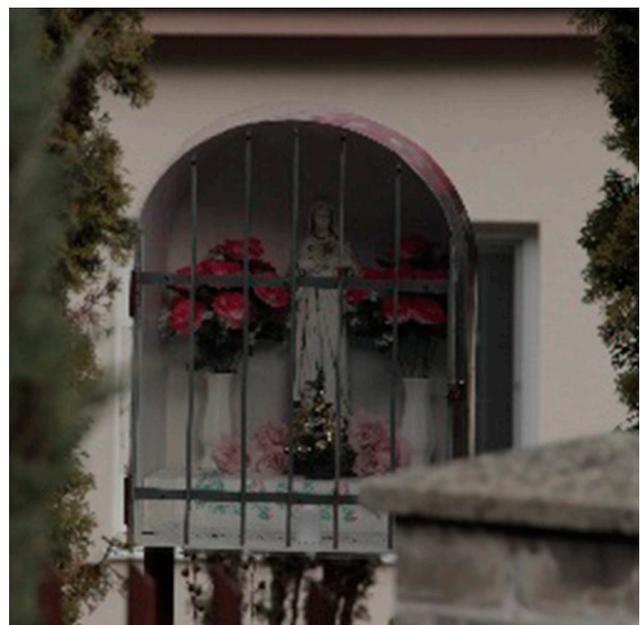
Figure 13 Small sacral box in residential garden
Photo: Fusková, 2018

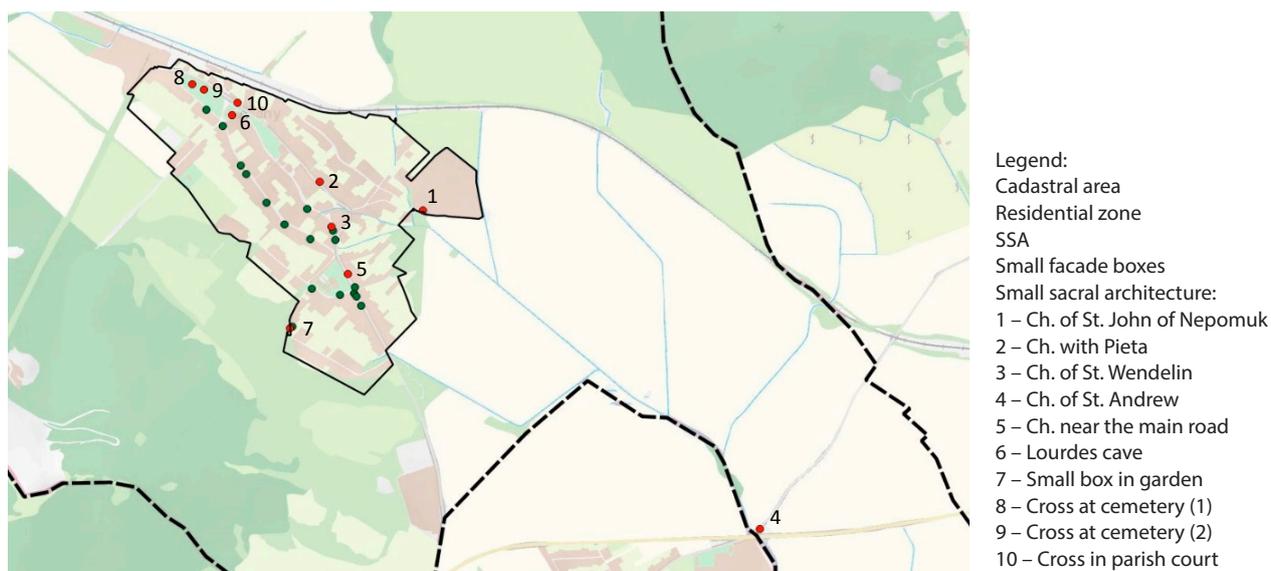
Figure 17 Map of small sacral architecture objects of village Žirany
Source: made by the authors

The analysis process according to the methodology of the VEGA project (2018) resulted in creation of the Map of

small sacral architecture objects of the Žirany commune (Fig. 17) based on GPS of its location. One of the facts that can be discussed is that SSA objects mapped in the area (except one case) are not accompanied by greenery. Tóth and Verešová (2018) mapped SSA in relation to old trees and mentioned their cultural and spiritual value. In our territory, the missing presence of trees can be caused by location and its lack of space for greenery. Front yards of residential houses where chapels were found did not provide space for plantation. On the contrary, the chapel on the way to Jelenec acts as a landmark on the cross-roads; it is a part of the countryside thanks to the outlook axes. Along the road, an alley of trees was planted later, although it is assumed that the lime tree next to the chapel is older due to its growth compared to other alley trees. Small boxes with statues of saints mounted in the facades of residential homes remain a question. These elements were not found in any of the surrounding villages in the same form and number as they were in Žirany. The small altars of Virgin Mary and Jesus in houses of the 1960s related to the dedication of the dwellings, and huge number of objects incomparable with the surrounding area could be related to the numerous citizens of Hungarian origin in Žirany.
